Busforsale.com ~ Bus Inspection

Dark Horse

2015 Prevost H3-45

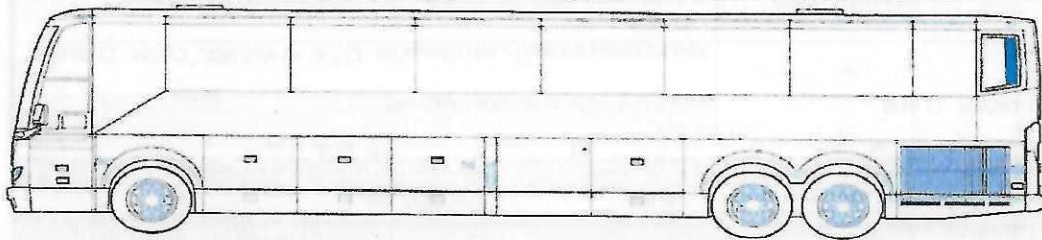
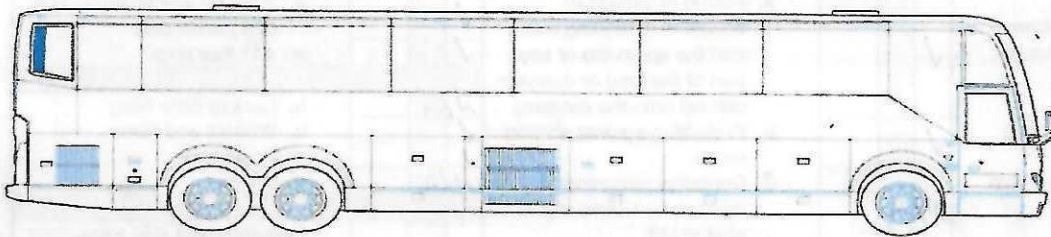
Front View

| Front Bumper | <input checked="" type="checkbox"/> | <input type="checkbox"/> | <i>Paint chipping off</i> | | | | |
